TOOTH TIPS

Noise is affected by the accuracy of the profile, lead, and spacing.

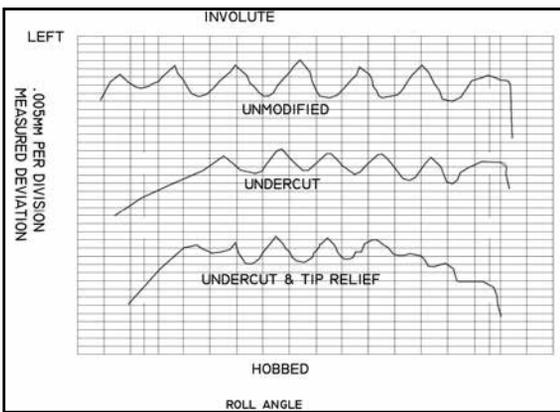
Figure 1: Three hobbed profile traces.

THIS COLUMN MARKS THE END OF A THREE-PART DISCUSSION on control of the three basic elements: profile, lead, and spacing. Figure 1 depicts three hobbed profile traces. The middle trace shows an undercut that is quite common and is manufactured by the addition of protuberance on the tip of the cutter. This provides clearance for the shaving cutter tip and reduces the amount of work done by the tip of the cutter. The bottom trace shows both an undercut and a tip relief. The undercut in this case would be unacceptable because there would still be non-cleanup above the SAP. The tip relief is also used more in fine pitch gears to reduce the deflection of the tip during the gear tooth manufacturing processes.

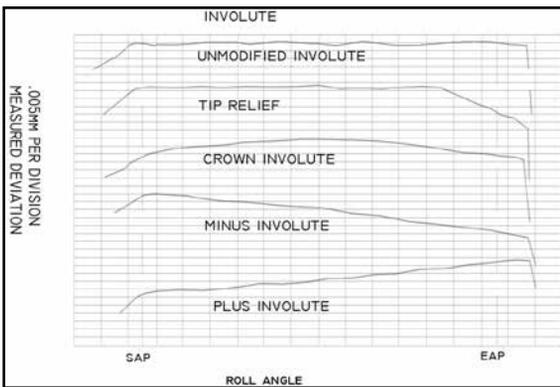
Figure 2: Five profile shapes on a finished gear.

Figure 2 identifies five different profile shapes on a finished gear, the first one being unmodified. The second and third are deliberate modifications induced to provide better running conditions. The fourth and fifth traces, while not normal modifications, are nevertheless very common, especially in form ground gears. The minus involute occurs when the part is finished undersize and the positive involute occurs when the part is ground oversize.

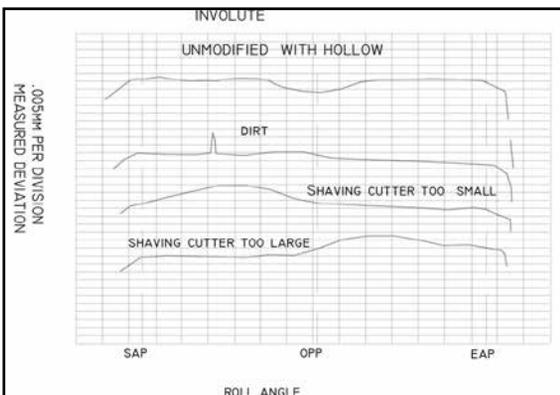
Figure 3: Involute forms from shaved gears.

Figure 3 shows different types of involute forms from shaved gears. The top involute indicates that the shaving cutter does not have the correct form or requires sharpening. This phenomenon also occurs if the tooth is worn in operation.

The second trace shows a common occurrence in the inspection area. Gears are normally cleaned with a brush a hair, which can stick to the profile. Because of the high resolution of the probe, a thin hair—in this case approximately .0005"—can result in what you see.

The third and fourth traces are a result of the shaving cutter being out of balance. That is the pressure on the shaved tooth is not the same as it rolls through mesh.

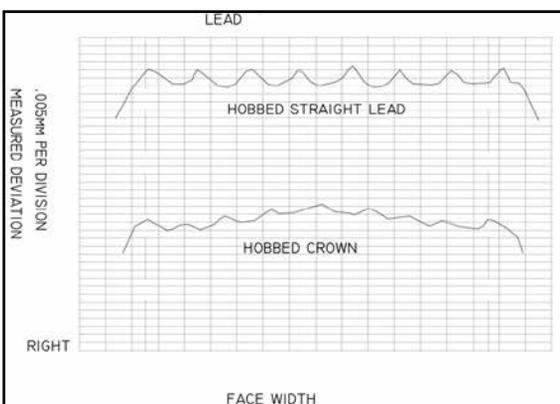
Figure 4: Lead surface after precision hobbing.

Figure 4 shows the lead surface after a precision hobbing operation. The depth of the scallop is important as it affects the subsequent shaving process or grinding process. All gear flanks should be cleaned up, including removal of all previous operation tool marks.
